Preface

Asuka Palace Site (National Historic Site)

The 192st excavation of the Asuka Capital Site Open Days Leaflet
November 8th and 9th, 2025

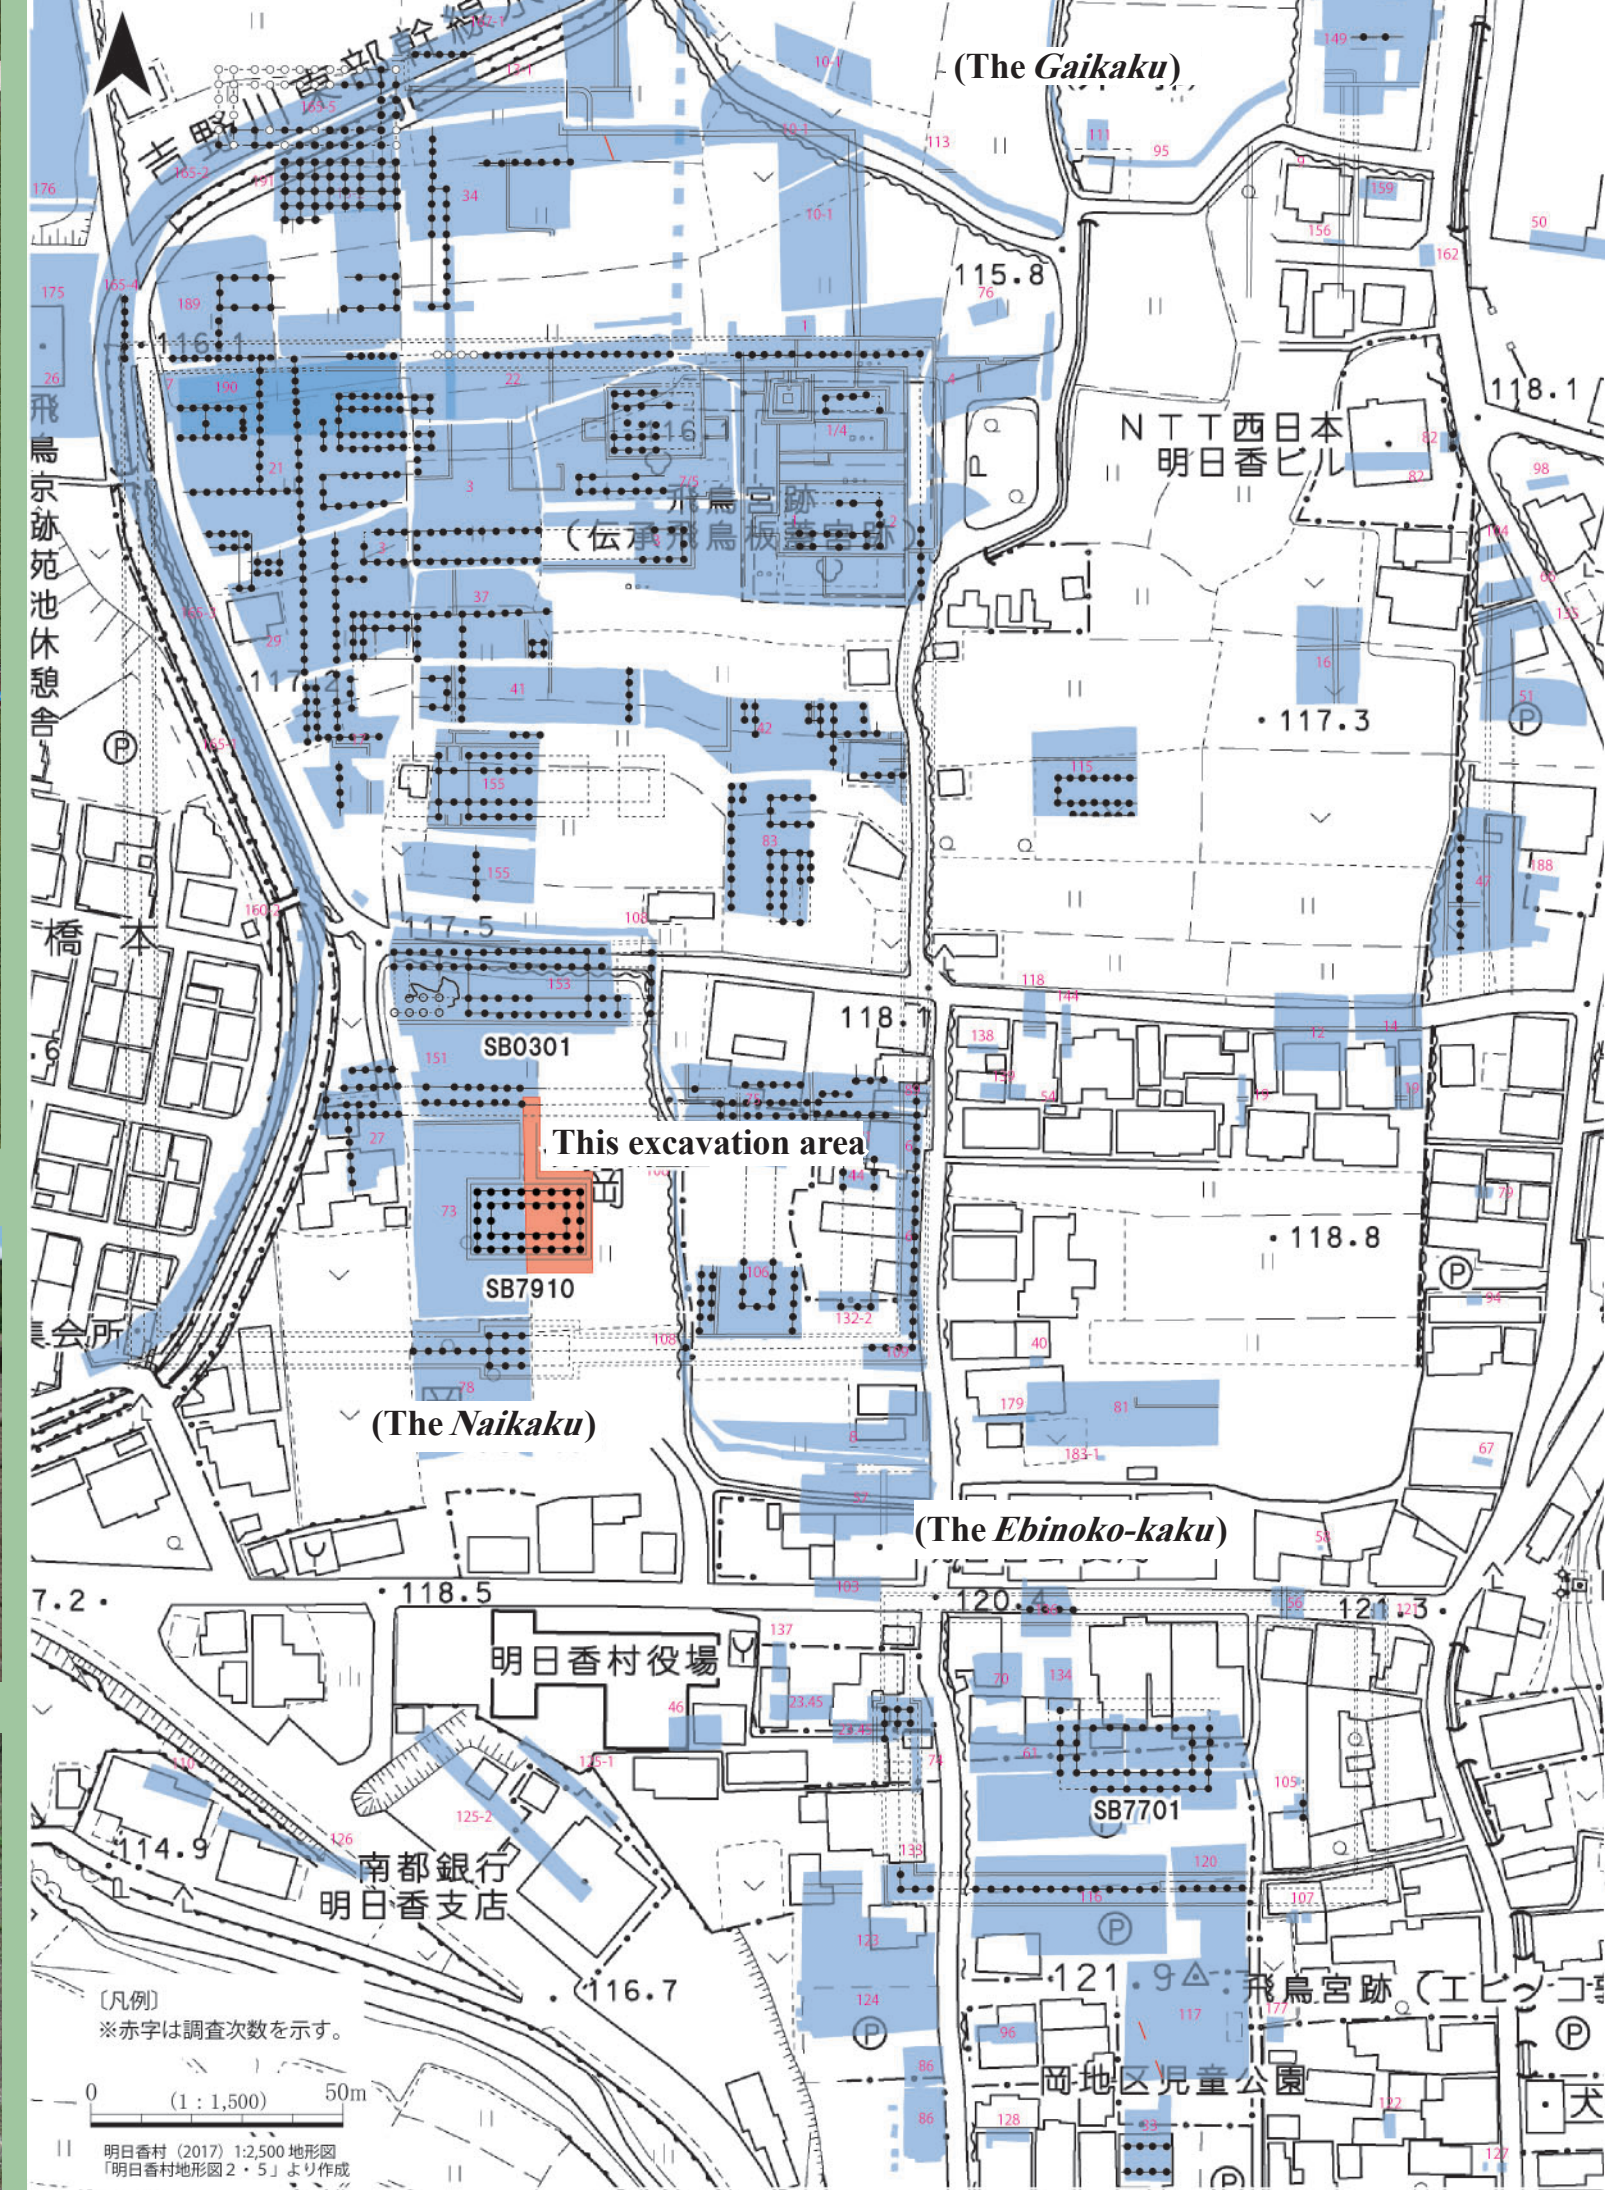
This excavation area at Asuka Palace Site

①Building SB7910: Based on the 73rd excavation, it was presumed that SB7910 could be a building measuring approximately 20.0 m east-west and 11.2 m north-south. The four sides of the building are thought to have faced the four cardinal directions, with *Hisashi* (eaves) on each side. In this excavation, post holes and pillar removal holes, as well as the stone pavement SX7916 surrounding the building, were unearthed from the anticipated locations, thus confirming the structure and size of the building.

Viewed in its planar form, the shape of each post hole is irregular, measuring approximately 0.8 to 1.7 m per side. As with the results of the 73rd excavation, all posts are thought to have been removed. The estimated *Hashirama*(span between pillars) is about 2.94 m for *Moya* (main building) and 2.65 m for *Hisashi*.

Small post holes have been found around the *Gawabashira* (pillars erected outside of a building) and *Irigawabashira* (those erected inside). Each are located at the intersection of two imaginary lines connecting the *Gawabashira* and *Irigawabashira*. These small post holes, judging from their locations and stratigraphic positions confirmed in this survey, may be the traces of scaffolding holes that were created for demolition.

Through this excavation, it was confirmed that SB7910 measured approximately 20.0 m east-west and 11.2 m north-south, with eaves on all sides. The stone pavement surrounding SB7910 runs up to the *Hashira-dori* of SB7910’s *Gawabashira*, and the inner stone pavement was placed one step higher than the outer pavement, which suggests sophistication in design. The fieldwork also found small post holes that may have been used as scaffolding holes for demolition.
